Phase I Environmental Site Assessment – Portac, Inc. Beaver Mill and Forks Mill, Clallam County, Washington

Phase I Environmental Site Assessment – Portac, Inc.

Beaver Mill and Forks Mill, Clallam County, Washington.

Prepared by Parametrix, Portland, Oregon.

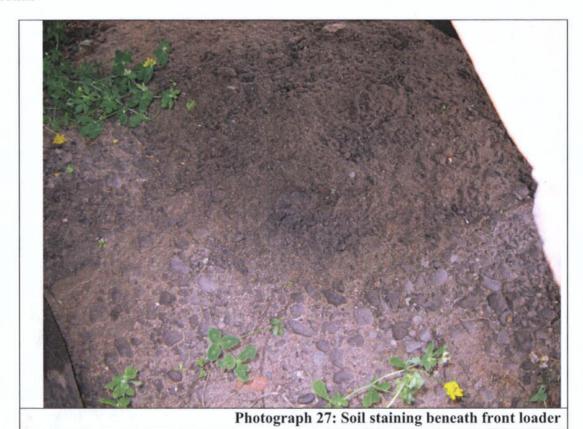
A small oil stain was observed beneath a front loader located northeast of the sawdust shed (Photographs 26 and 27).

Photograph 26: Front loader dripping oil to soil

- Areas of identified oil stains and potential environmental impact should be inspected and cleaned up, as appropriate. All stained soil should be excavated and disposed in accordance with local and state regulations.
